CALSPAN LIMITED ON-SITE AIR BAG DEPLOYMENT INVESTIGATION

CALSPAN CASE NO. 91-1

FLEET - 1988 ACURA LEGEND LS

ACCIDENT DATE - [REDACTED], 1991

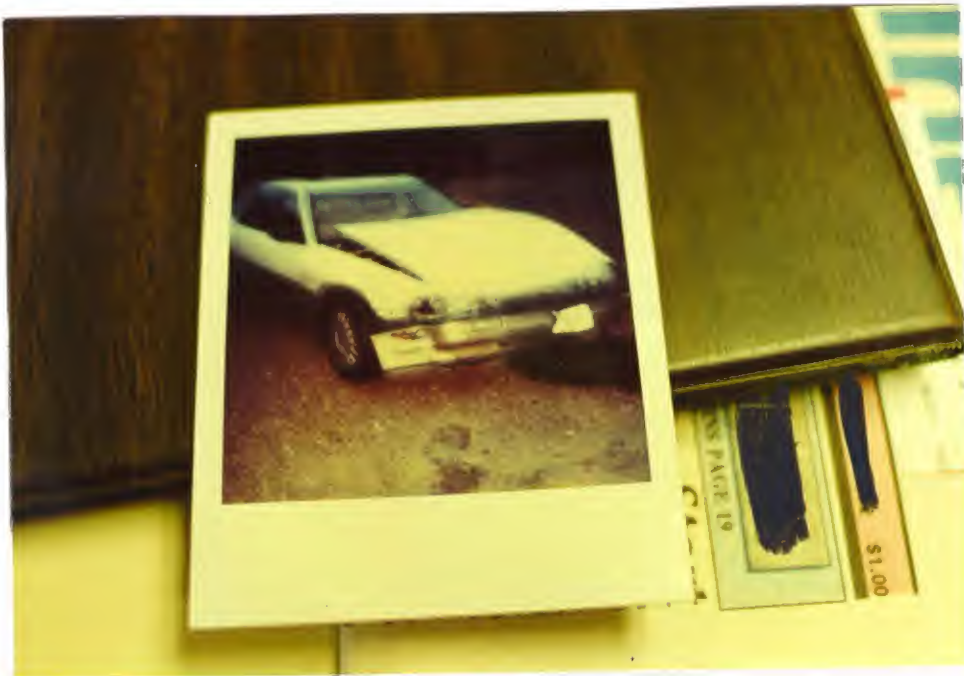
Frontal Damage To The Acura Legend

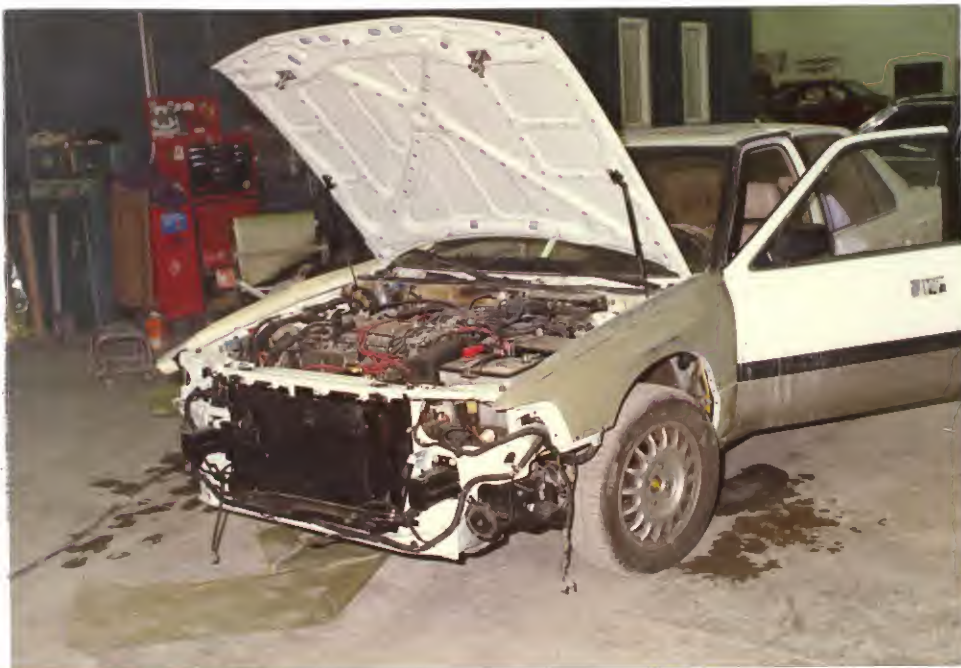
Left Front Three-Quarter View Of The Repaired Acura Legend

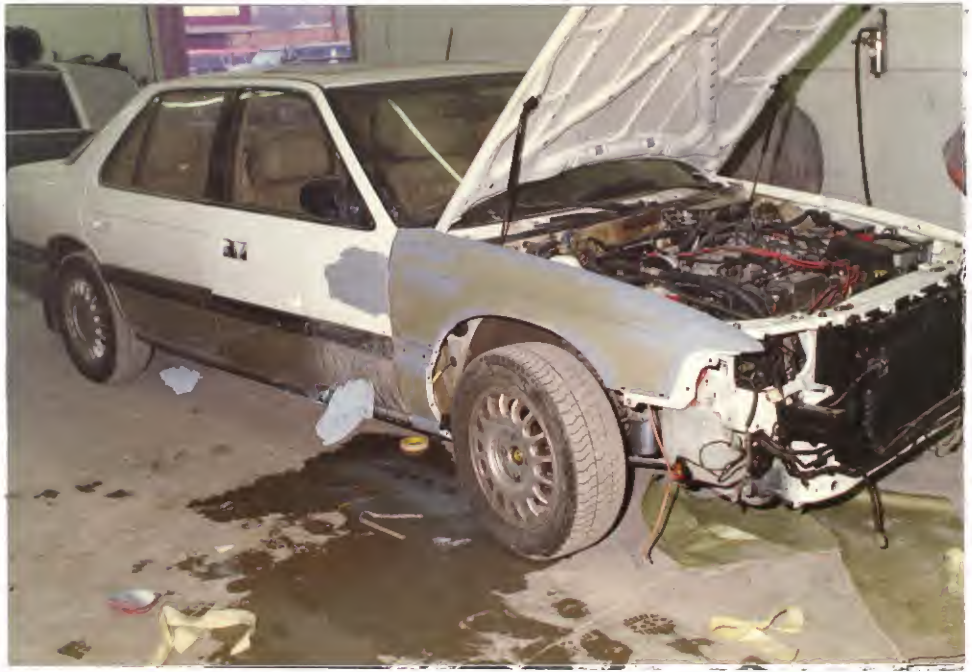
Right Front Three-Quarter View Of The Acura Legend

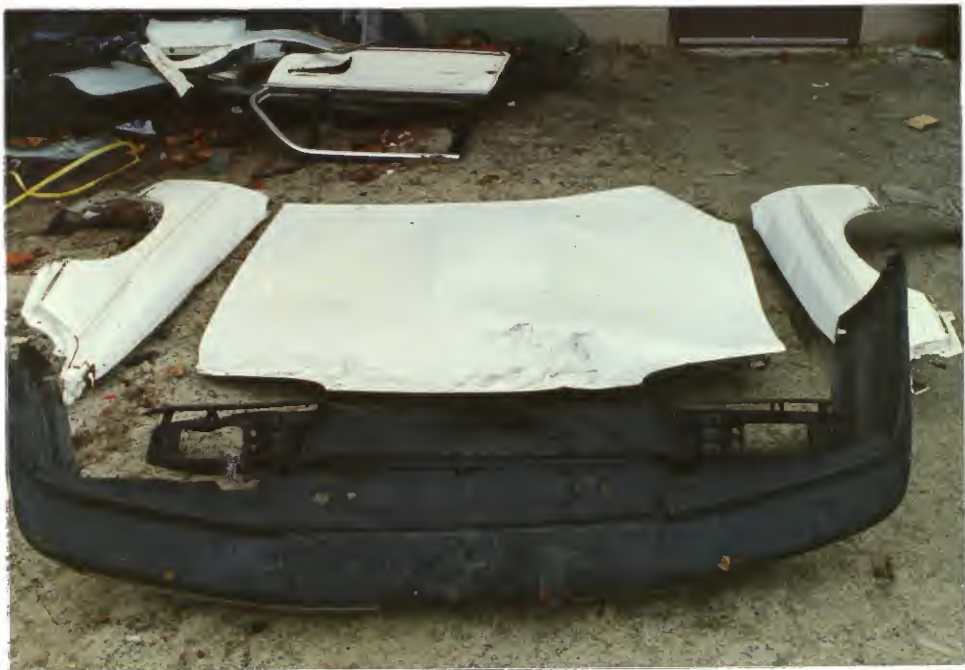
Damaged And Replaced Frontal Components

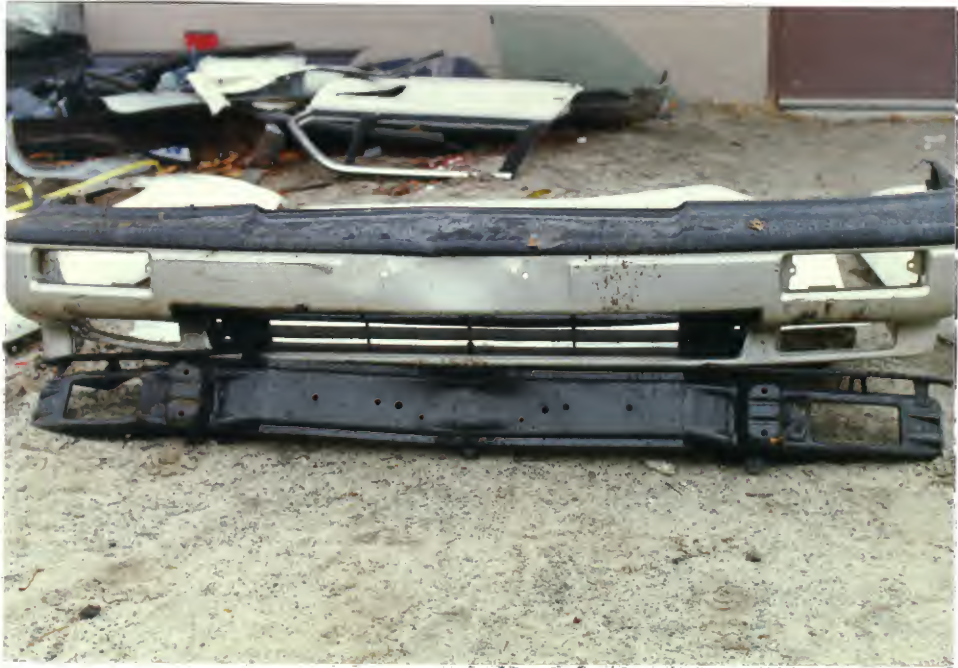
Damage To The Bumper Facia And Reinforcement Bar

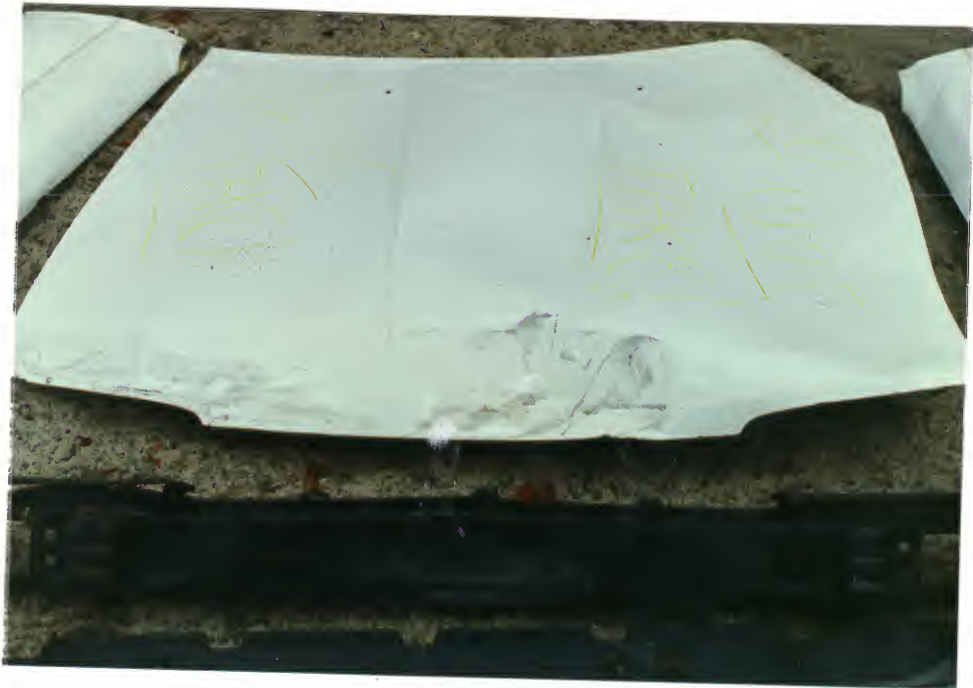
Hood Damage

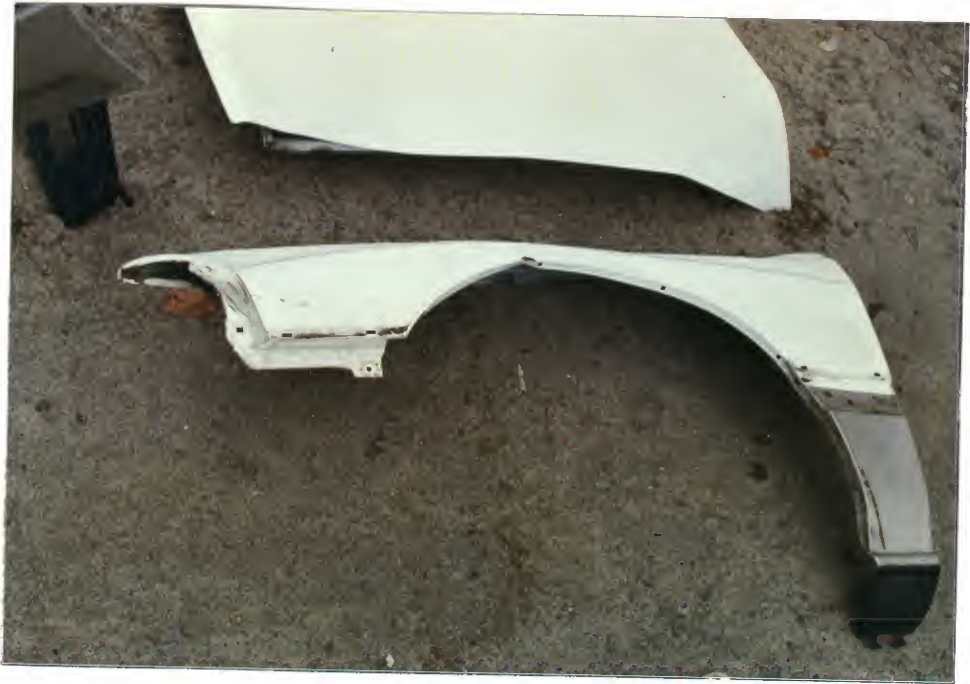
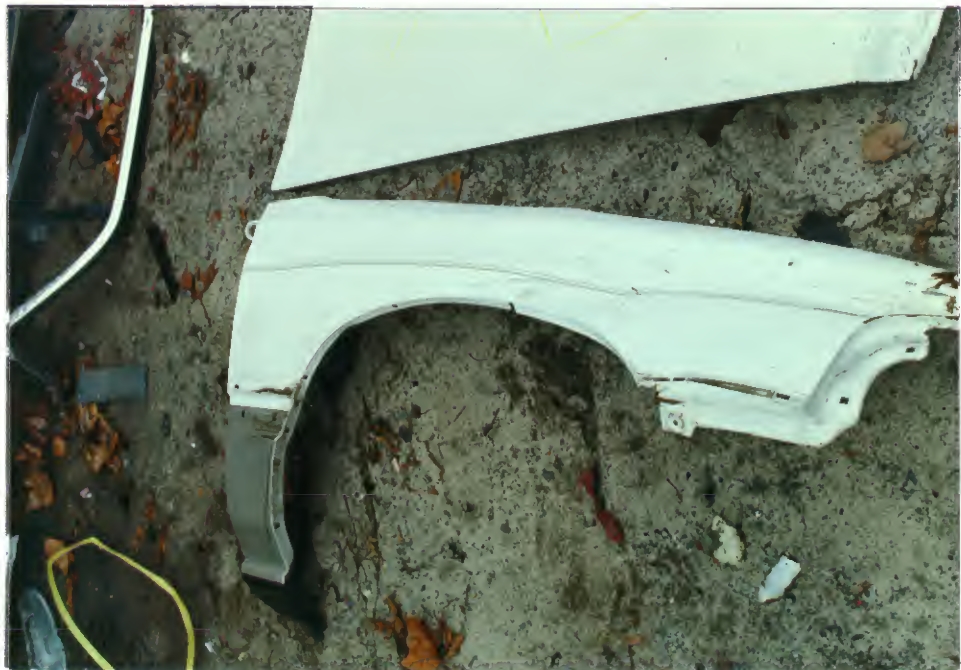
Damaged Front Fenders

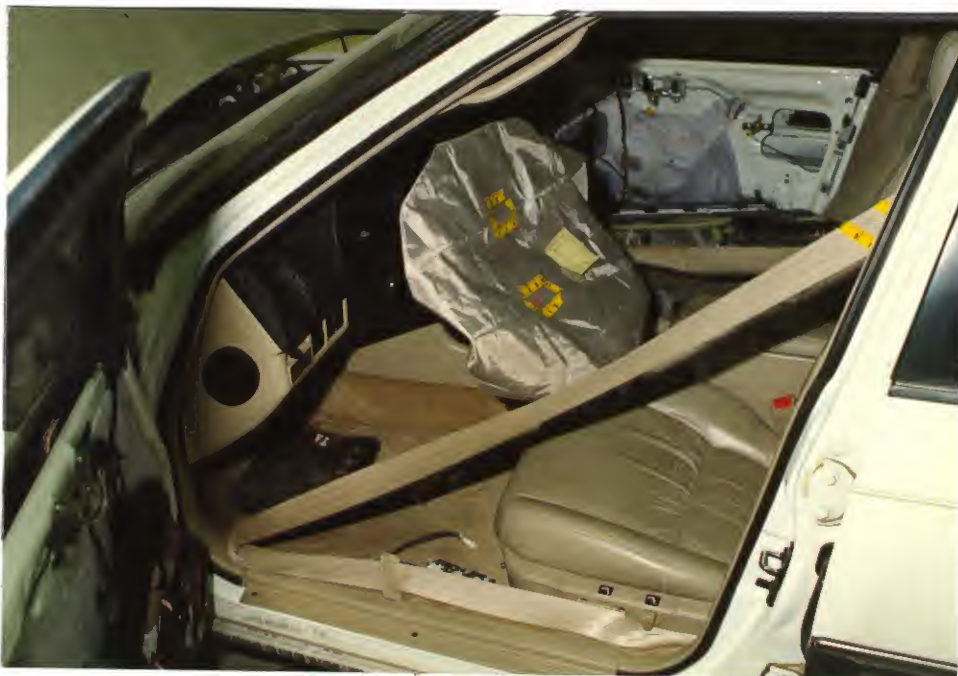
Overall Interior View Of The Deployed Air Bag
And Active 3-Point Belt, Webbing

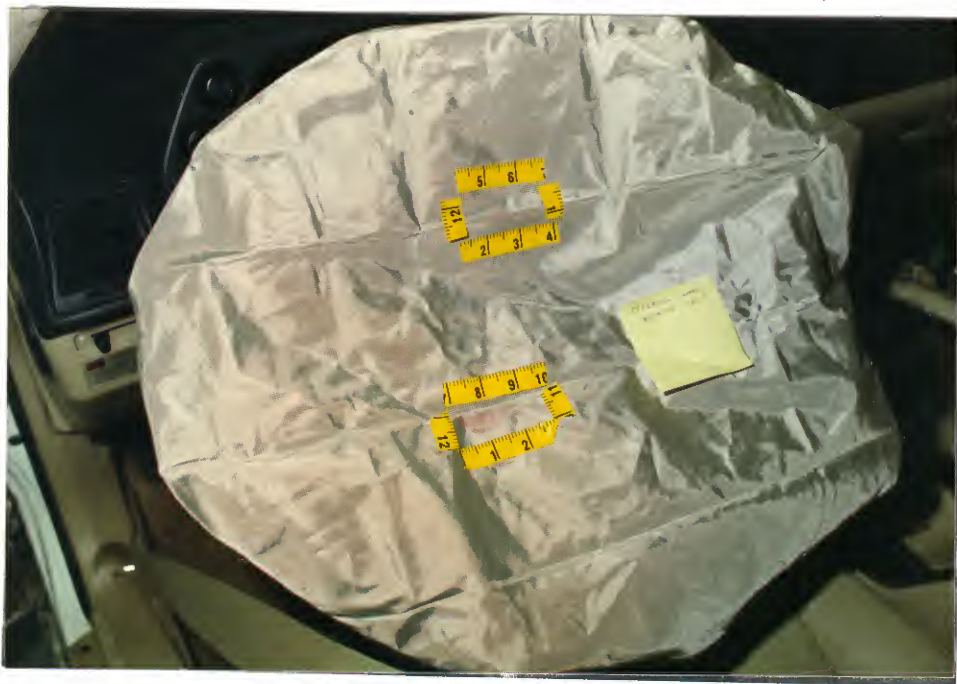
Interior (Air Bag Vehicle) (Cont'd.): deployed air bag depositing lipstick and suspected makeup transfers on the face of the bag. The lipstick transfer was located 0-.75" below the horizontal centerline and 1-3" left of the vertical centerline. The makeup transfer (possible eye makeup) extended 4.75 - 5.5" above and .5" right to 1" left of the reference centerlines. All measurements were taken with the steering wheel rotated 180° from a straight ahead position.

Driver Facial Contact (Lipstick And Makeup Transfers) To The Deployed Air Bag

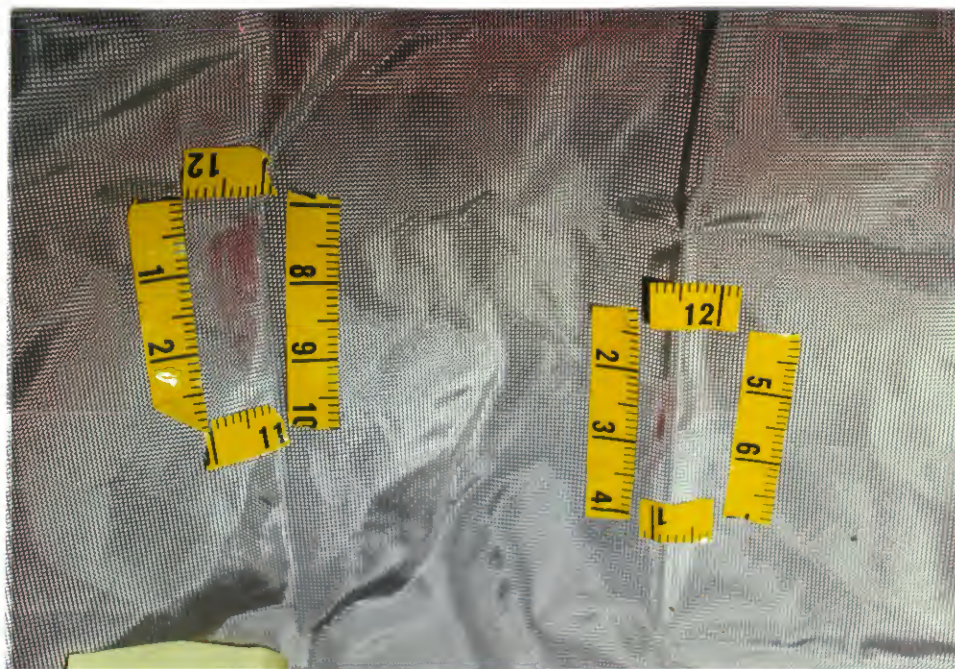
Closeup Views Of The Facial Contacts

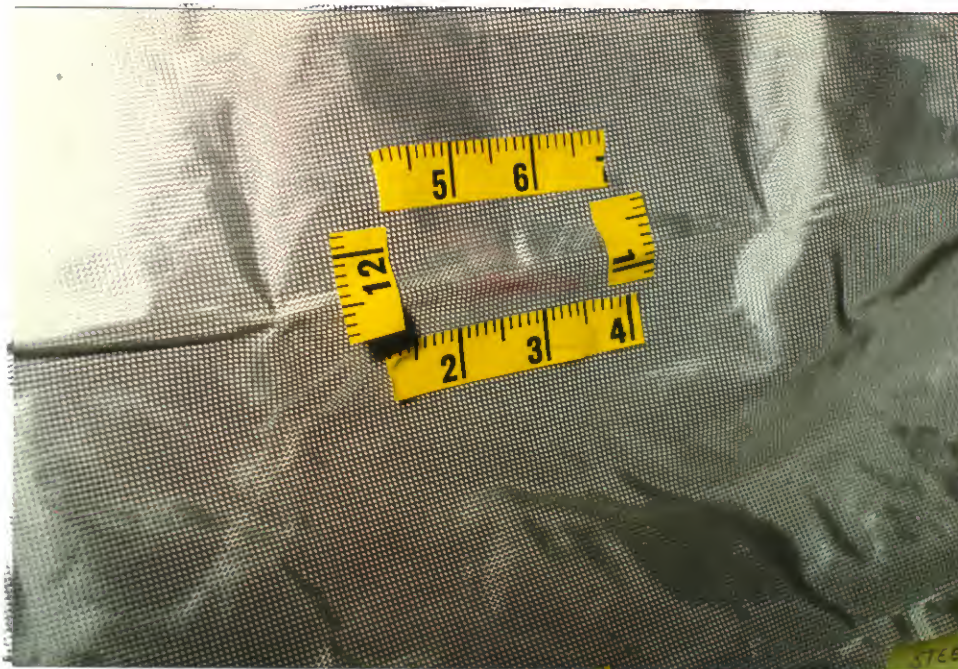
Eye Makeup Transfer On A Fold Crease

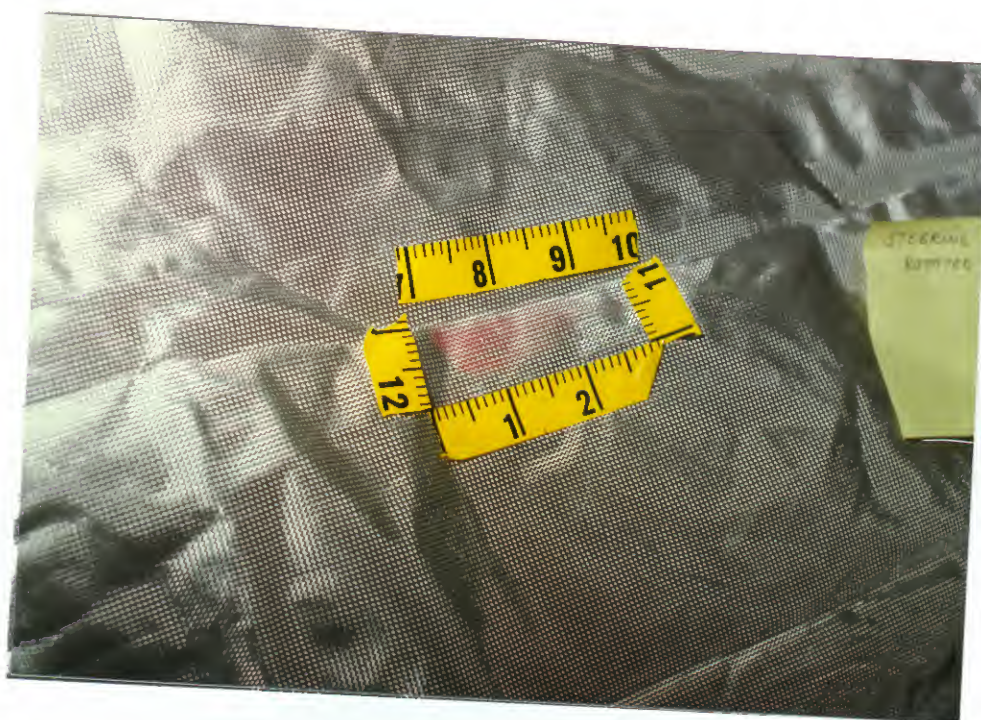
Closeup View Of The Lipstick Transfer

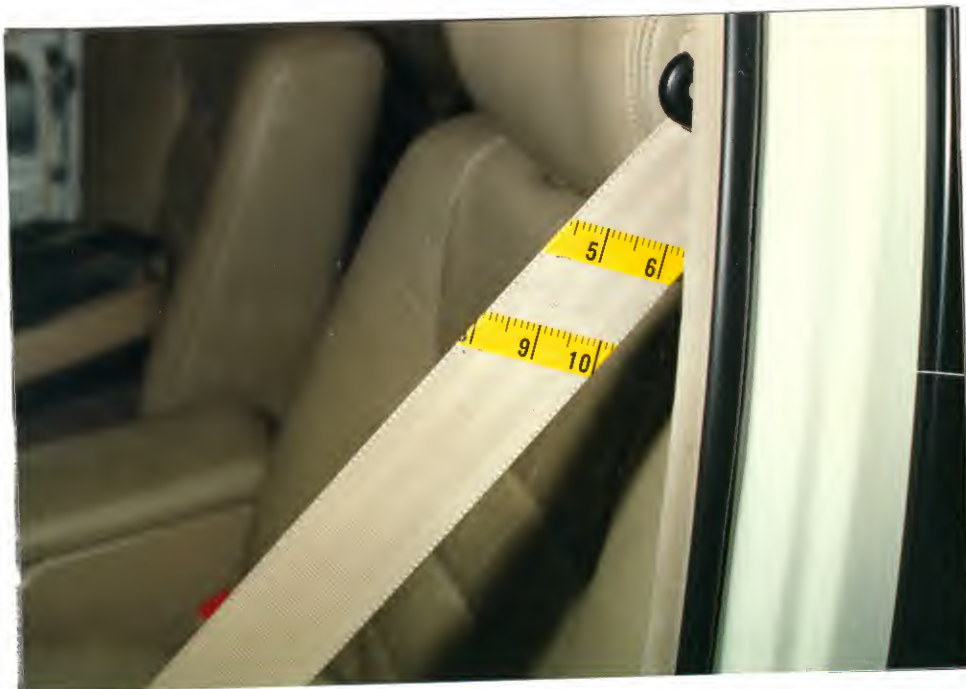
The driver loaded the active 3-point belt system as she initiated her forward trajectory. Her loading force on the shoulder belt webbing produced a black plastic transfer from the B-pillar mounted D-ring. The driver sustained superficial abrasions of the anterior left neck and shoulder from the shoulder belt webbing. The active and passive restraint systems were effective in preventing the driver from contact with additional interior components and potential further injury.

D-Ring Transfer On The Shoulder Belt Webbing From Driver Loading

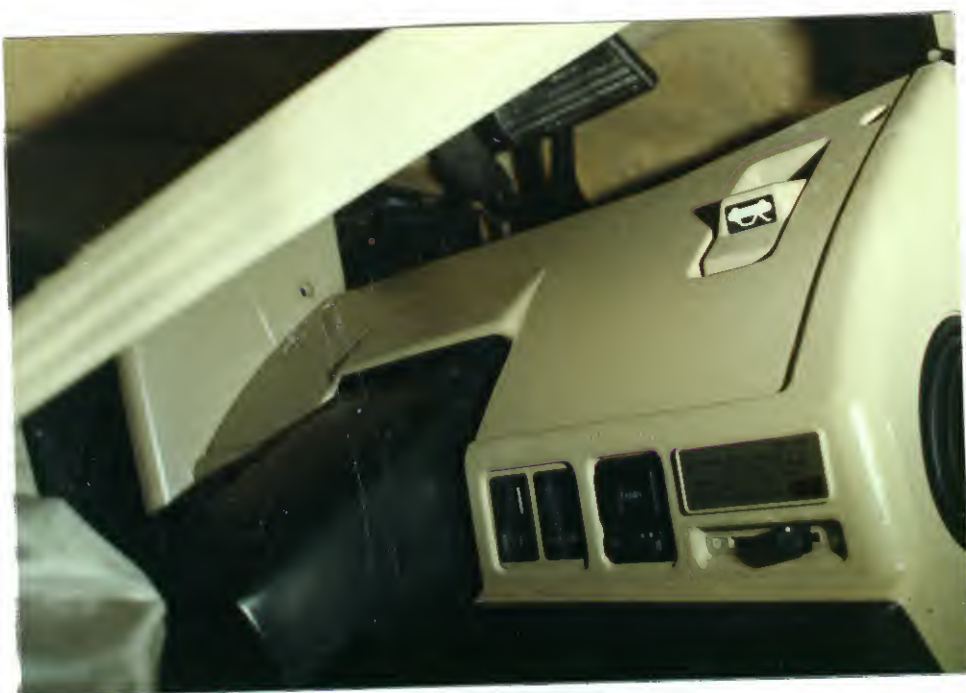
Driver Knee Bolster, No Evidence Of Driver Contact

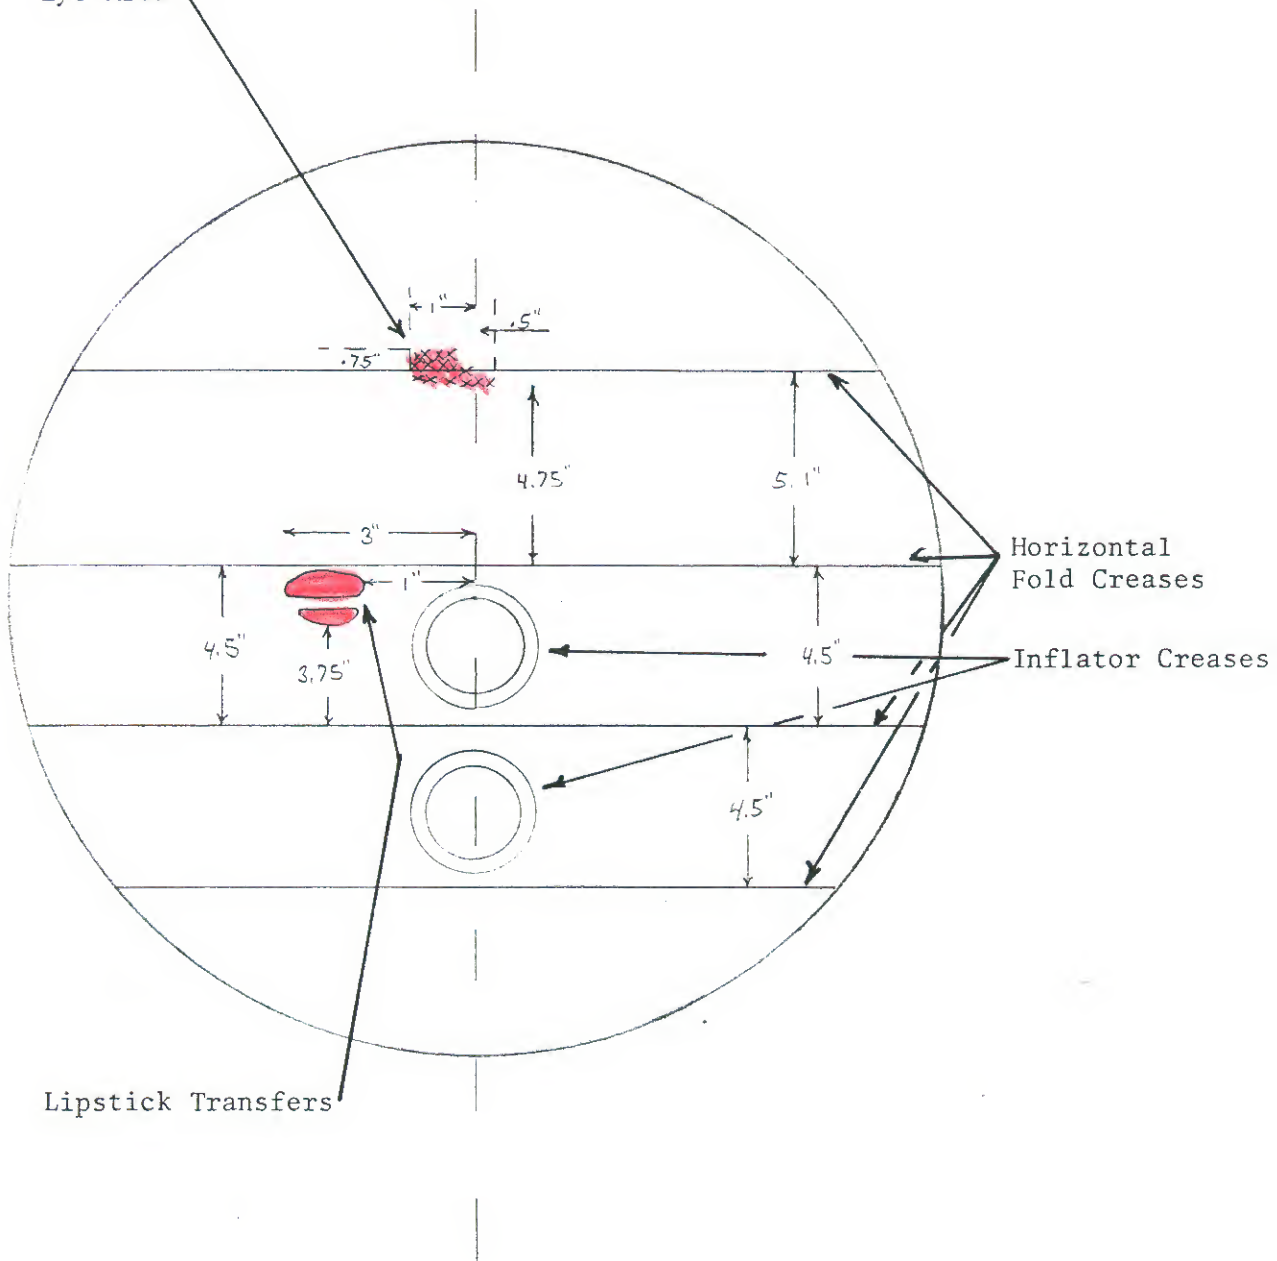
Air Bag Contact Schematic

Makeup Transfers, Possible
Eye Area
